TREE INSPECTION REPORT AND WOODLAND MANAGEMENT RECOMMENDATIONS: THE CHILDREN'S WOOD, NORTH KELVIN, GLASGOW

**Prepared for The Children's Wood
January 2016**

**TREE INSPECTION REPORT, THE CHILDREN'S WOOD, NORTH KELVIN,
GLASGOW**

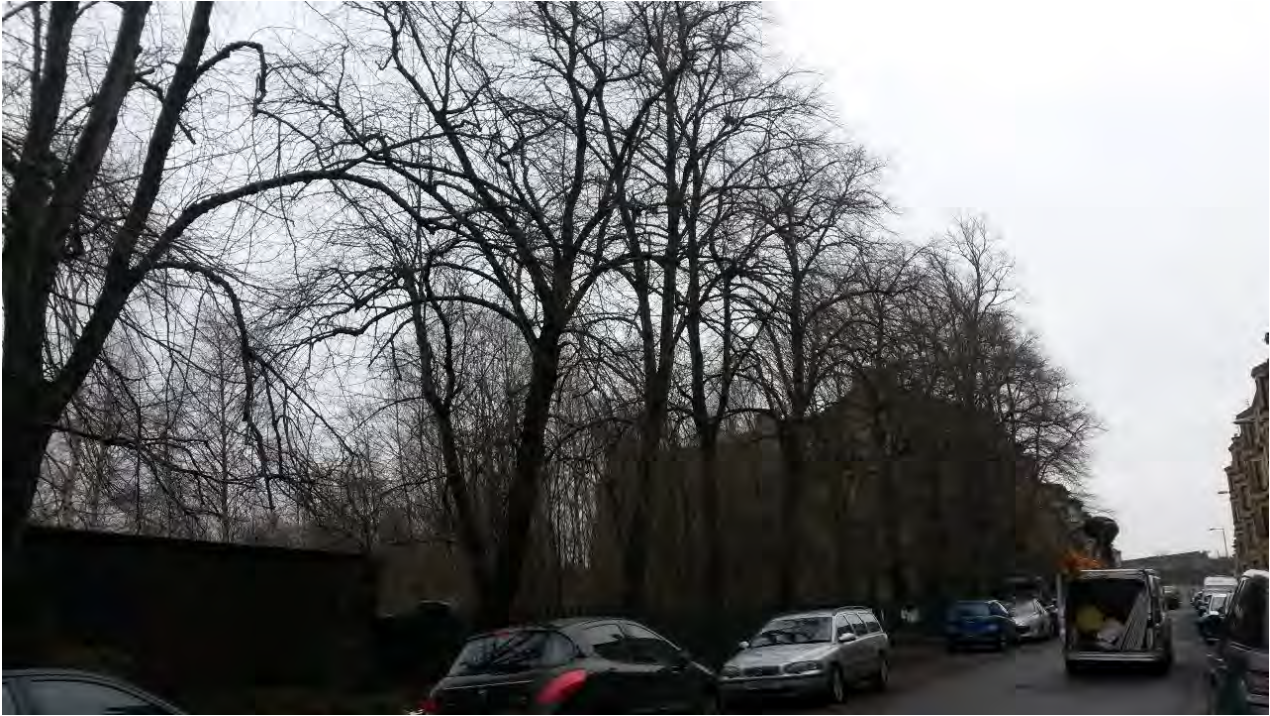
most as would be expected of lime trees of this age. There is a cavity at 2m on the south side of the stem of tree 3987 which requires further investigation to assess the extent of the cavity and the integrity of the surrounding wood. Given the proximity of the trees to the road and pavement, complete dead wooding of several of the trees is recommended (refer to Appendix 1 for details) to avoid damage to persons or property during high winds. The lower canopies of some of the trees are beginning to encroach on the highway and it is therefore recommended that where the canopy of a tree extends over the footpath, it is raised to a height of 2.5m and where it extends over the carriageway, it is raised to a height of 5.2m to avoid damage to branches from passing high-sided vehicles. The ground conditions within the root zones of the trees are showing signs of compaction, particularly tree 3982 which has an informal path passing through its root zone extending from a hole in the fence.

Photograph 1: *Lime trees (Tilia x europaea) on the Clouston Street boundary protected by Tree Preservation Order*

The trees would all benefit from regular mulching with, for example, wood chip, pulverised bark or leaf mould combined with well-rooted animal manure, particularly in the outer root zone where the majority of the feeder roots are found. Care should be taken when applying mulch to avoid the bark of the stem and major structural roots protruding above ground as this may encourage infection from pathogens. Ivy on the trunks and excessive epicormal growth prevented detailed inspection of the lower trunks of some of the trees. Given the proximity of the trees to major targets (residential property, pavements, public road, parked cars etc.) epicormic growth and ivy should be removed from the stems and the stems kept clear to allow for regular thorough inspection. Ivy is also becoming an issue on the ground and the dense mat that is developing is smothering other plants. Effort should be made to control the ivy growth on the ground and encourage the development of a more diverse ground flora.

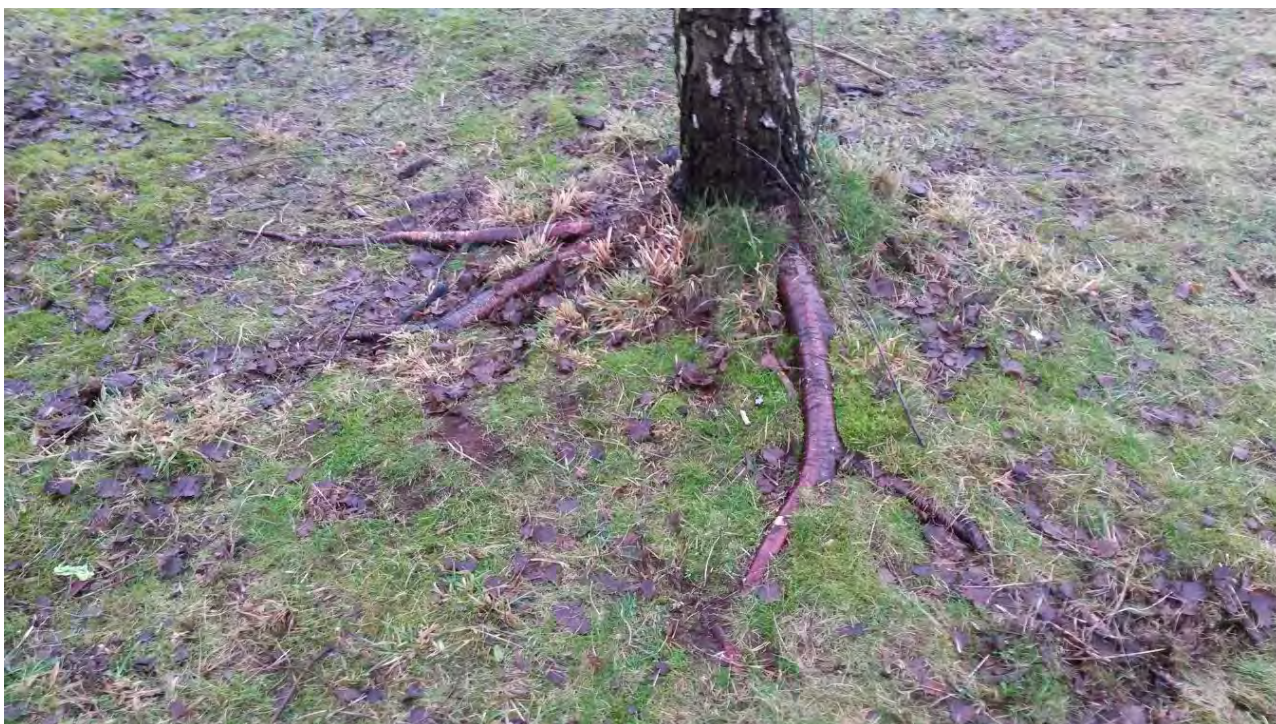
In all of the areas of woodland described below the woodland has developed on blaes and the compacted nature of the rooting medium has resulted in poor rooting conditions and exposed roots as a result. The extent of compaction and poor rooting means that the trees on the site will be more vulnerable to windthrow as they gain height and mature. There is an urgent need throughout the site to introduce management techniques to reduce compaction and improve aeration and nutrient status of the rooting medium by soil cultivation (with hand tools to minimise damage to tree roots) and frequent mulching (with well-rotted bulky organic matter) to improve nutrient levels and encourage the development of soil

Photograph 2: *Compaction and poor rooting medium has resulted in poor rooting throughout the site leaving the trees vulnerable to windthrow.*

structure. All leaf litter should be left on site (within the woodland areas) or composted and returned to the root zones of the trees.

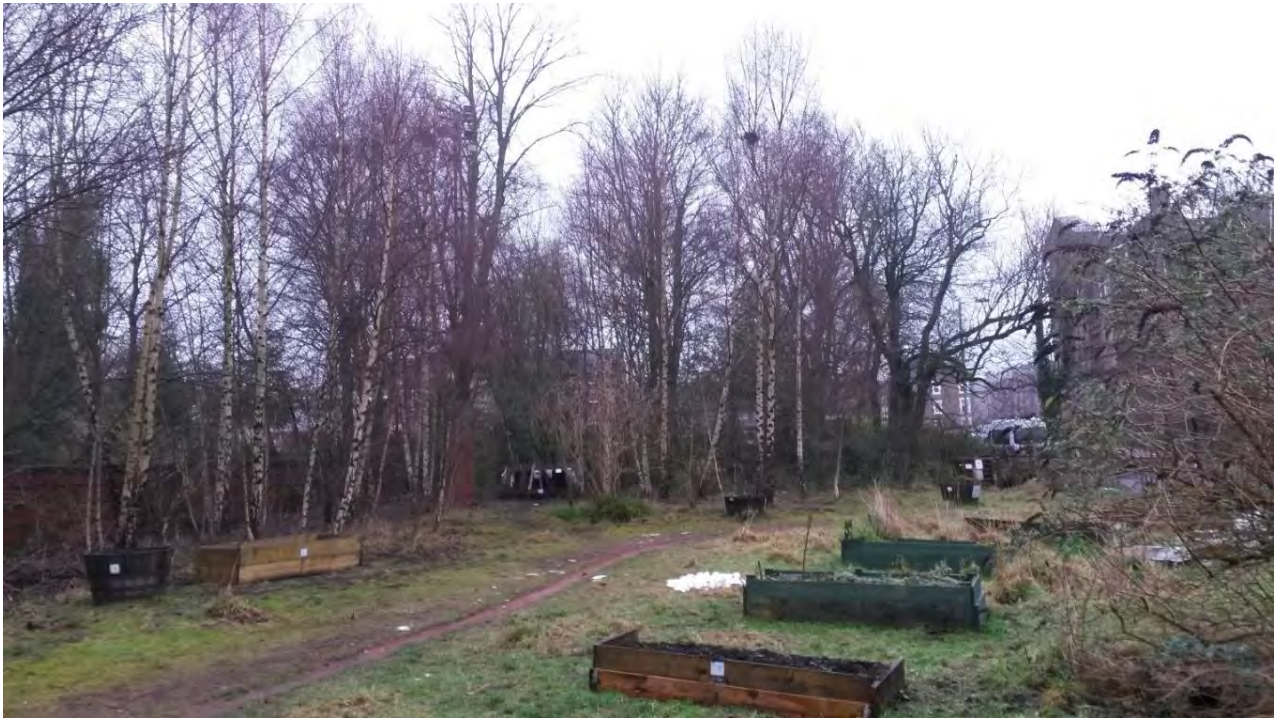
Photograph 3: W1 with community garden in the foreground

The ground vegetation in area W1 is becoming rank and dominated by aggressive weeds. The sward would benefit from some weeding, seeding and the introduction of a mowing regime (similar to that proposed below for the meadow). Some planting of (native) bluebells and snowdrops would be appropriate, particularly along the northern and western boundaries once the ivy and bramble is under control. Care should be taken to ensure that only native bluebells (*Hyacinthoides non-scripta*) are planted and not the invasive Spanish bluebell.

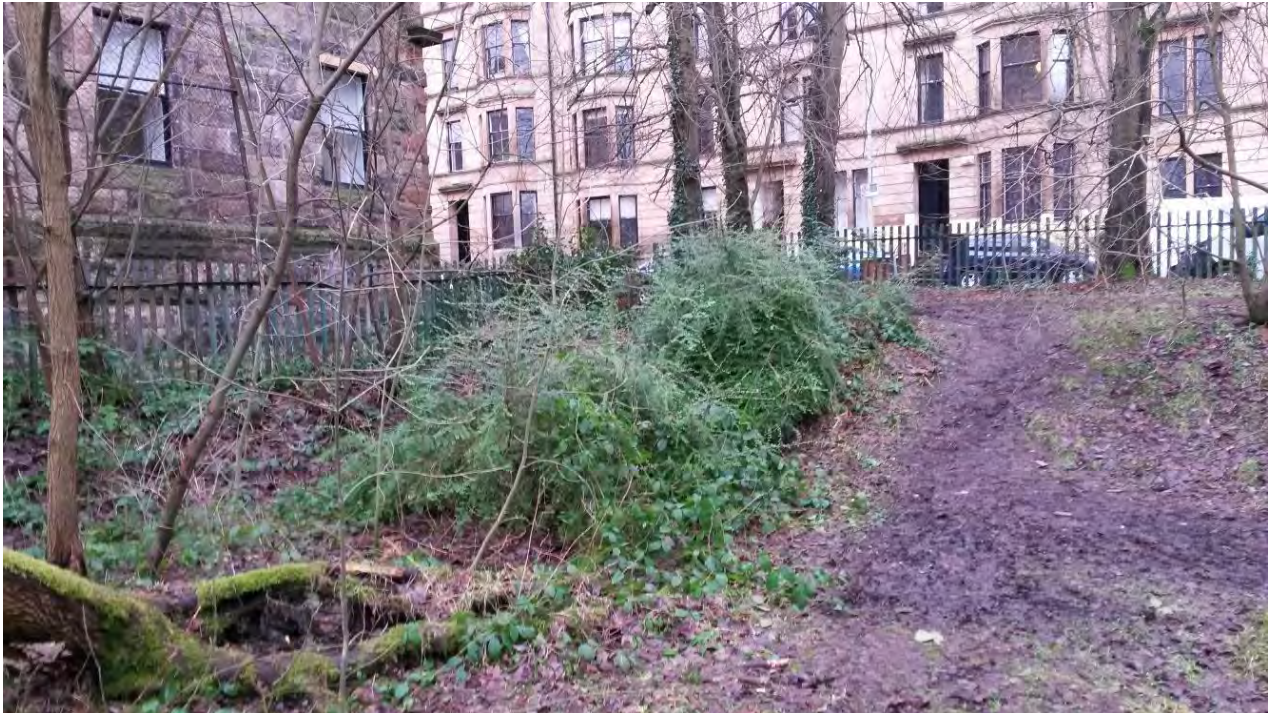
Photograph 4: *Lonicera nitida*, a garden escapee, in Compartment W2a

The garden escapees (particularly the *Lonicera nitida*) should be removed from the eastern strip of the site and supplementary planting should be carried out with hazel, holly. Several of the established birch trees within this area have developed stem sweep and should be removed once the ash saplings are more established. The aim here should be to encourage the development of low-growing woodland with occasional large trees so that the woodland does not become so dense that it causes excessive shading of the adjacent flats.

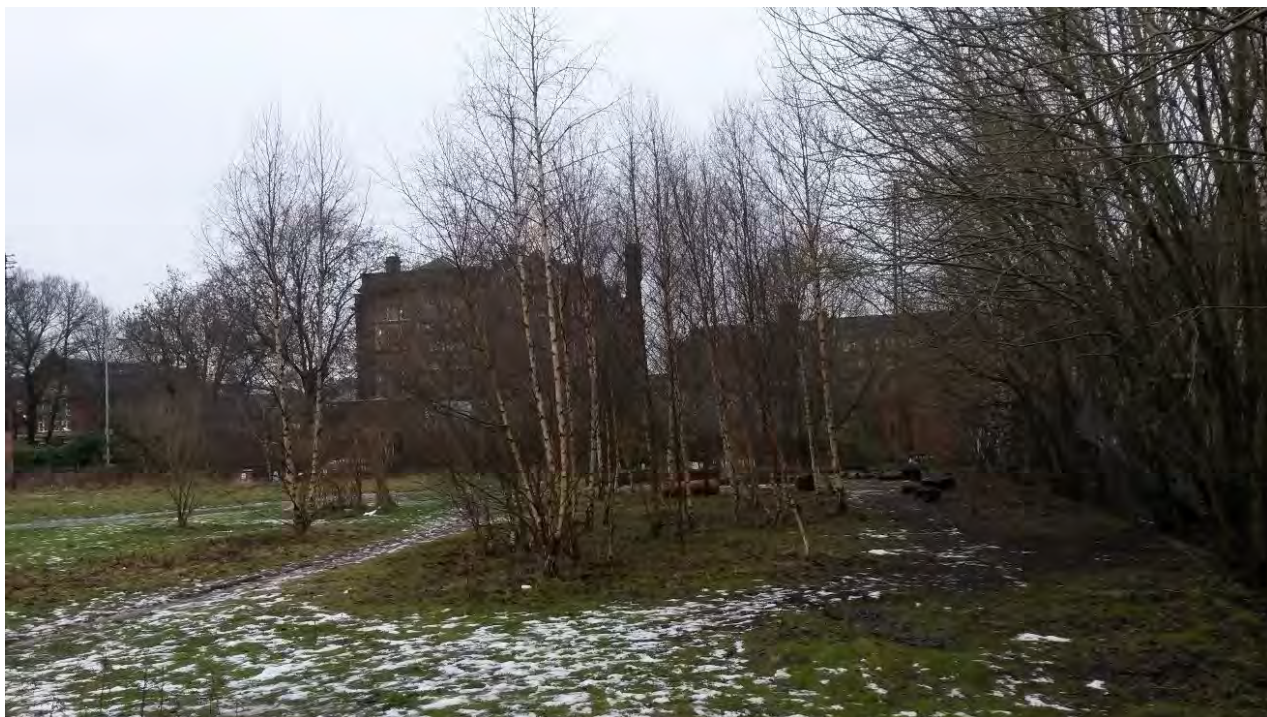
Photograph 5: Existing woodland in Compartment W3b

The existing woodland should be thinned in favour of the better birch specimens.

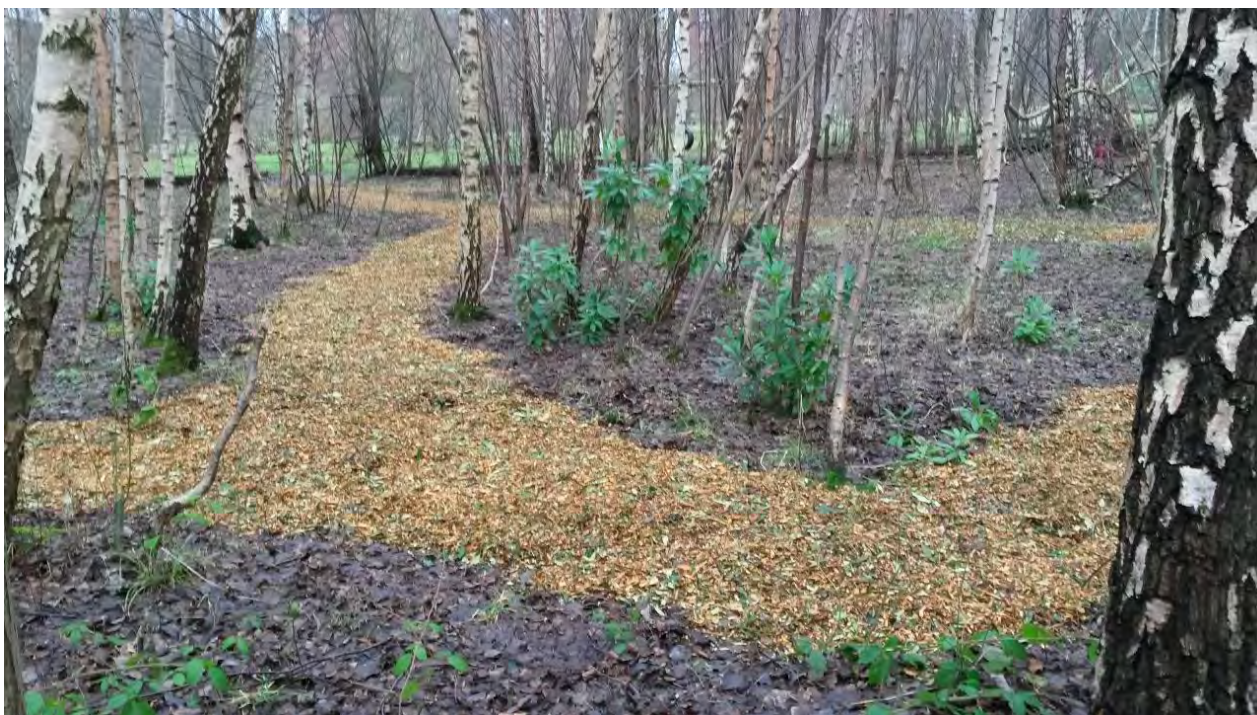
Currently there is a dense network of paths through the site, indicative of the high level of use the site receives. The resulting erosion and compaction is preventing vegetation from establishing in many areas. Work is progressing to formalise a path network through the site by delineating the preferred paths with woodchip. Ideally once the permanent path network is defined within the woodland areas, the other areas should be cultivated and planted to deter further use and to encourage development of field and understorey layers to the woodland. Once the permanent footpath network is well-defined and vegetation is established on the adjacent areas, the footpaths outwith the woodland areas could be scrapped back to the underlying blaes which is hardwearing and compact and with regular maintenance to remove leaf mould, fill holes etc. will provide an appropriate permanent wearing surface. Within the woodland areas on-going protection of the tree root systems will be required to minimise damage. Installation of 'no-dig' ground protection

Photograph 6: *Work is progressing to delineate the path network through the site using woodchip*

systems for heavily used footpaths and events areas could be considered or alternatively, on-going regular application of woodchip.

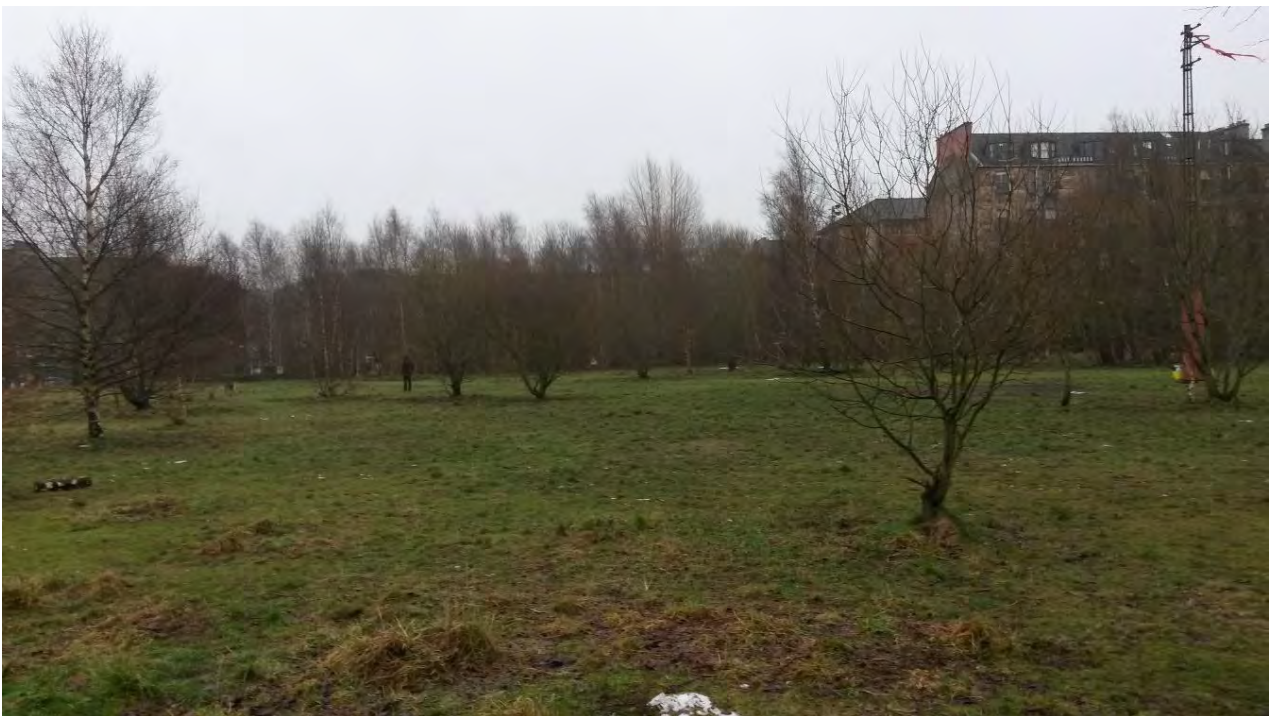
The meadow area is an important community resource that is well-used for informal recreation. As a result, it experiences a high level of trampling. The Committee's aspiration is to develop the area into a wildflower meadow but it is likely that continued heavy use of the area is likely to limit the success of this. It is therefore recommended that the central area is maintained as an area for intensive use while the peripheries and western site boundary are managed as wildflower meadows. Successful establishment of wildflowers requires low fertility, particularly for the establishment of calcareous grassland. Blaes is generally quite alkaline suggesting that the site would be suited to the development of a calcareous grassland.

Photograph 7: *Meadow area with willow natural regeneration*

In order to maintain and develop biodiversity interest it will be necessary to mow the meadow areas. In the first year the emerging meadow should be cut to maintain the sward at height of 10-15cm (but not less than 5cm). Cuttings should be removed from the site to retain low fertility. In the second and subsequent years the meadow will require cutting at least once, preferably in late summer/early autumn once the plants have flowered and set seed. An occasional spring cutting will help to keep pernicious weeds (e.g. nettle, docks, dandelions etc.) and developing scrub in check, although hand pulling or spot spraying with an approved herbicide may be more suitable management for small meadow areas.

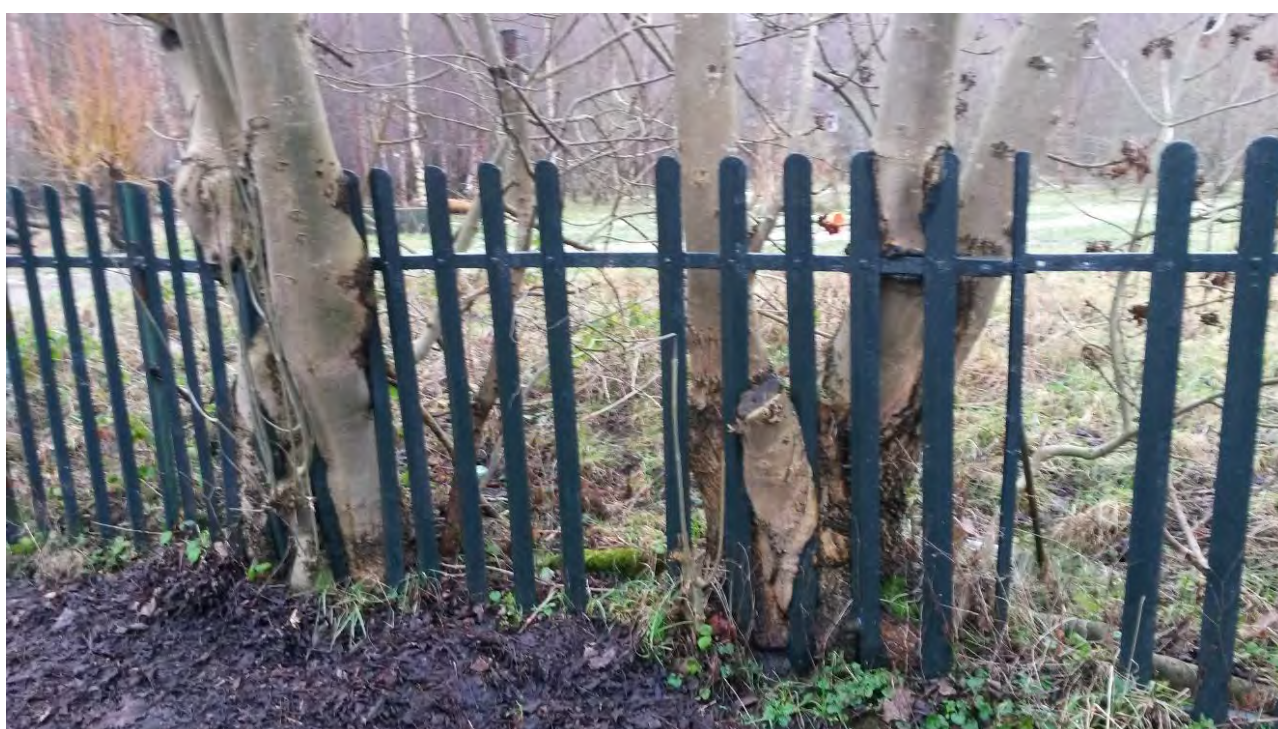
The metal palisade fence which extends along much of the site boundary is a feature of the area, particularly the Clouston Street and Kelbourne Street boundaries. Most of the fence is still present on site but is being damaged in places by tree regeneration. The trees growing through the fence are generally poor specimens that are damaged to a point that they will have reduced life expectancies. The roots of some of the trees on Kelbourne Street are also damaging the pavement.

Photograph 8: *Trees damaging the boundary fence on Kelbourne Street*

Ideally all of the boundary trees that are growing through the fence should be removed and the fence repaired. There are significant opportunities along the boundaries, particularly the Kelbourne Street boundary to establish trees set back from the boundary. Species such as rowan and whitebeam would create an attractive feature along the boundary to the west of the entrance. To the east of the entrance, bordering the woodland along Kelbourne Street and along the Sanda Street boundary it would be appropriate to establish a hedge. A suitable
