UNIVERSITY
of
GLASGOW

The John Martin Partnership

CONDITION SURVEY
OF OLDER PRIVATE HOUSES

REPORT
FOR
GLASGOW CITY COUNCIL

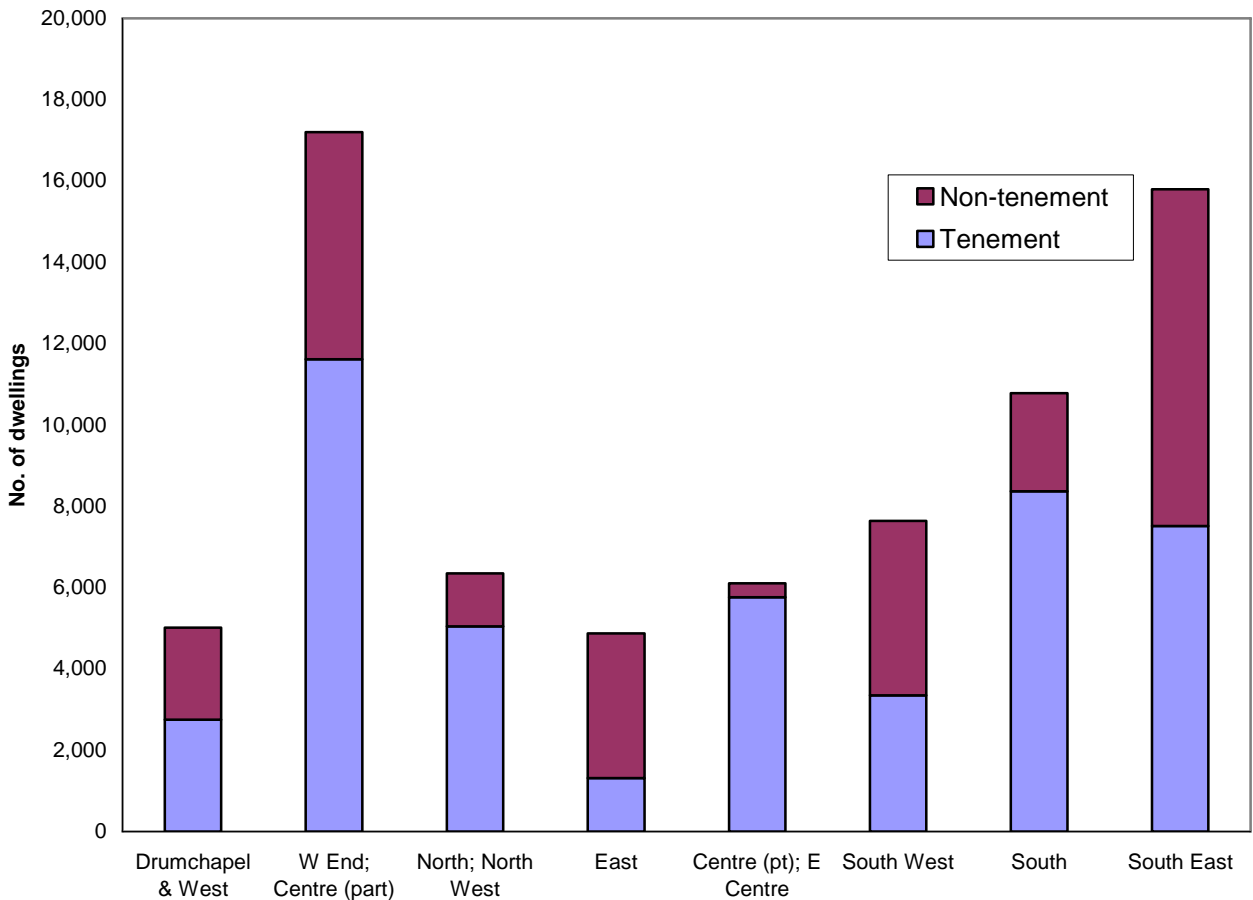
Chart 8.1: Property Types

- 8.1 This part of the survey looks at the physical make-up of the dwellings, their construction type, property type and age as well as some basic component descriptions.
- 8.2 Information relating to the condition of these property attributes is contained in Section 9.0 Condition and Repair.
- 8.3 The first part of this assessment looks at the basic dwelling information:
- Property type
 - Date of construction
 - Construction types
- 8.4 The survey categorised the properties into two distinct types, tenement and non-tenement. This was the basis upon which the stock was originally sampled. The breakdown can be seen in table 4.4 above and is summarised in chart 8.1 below: Tenements predominate except in South East and Centre/East Centre.

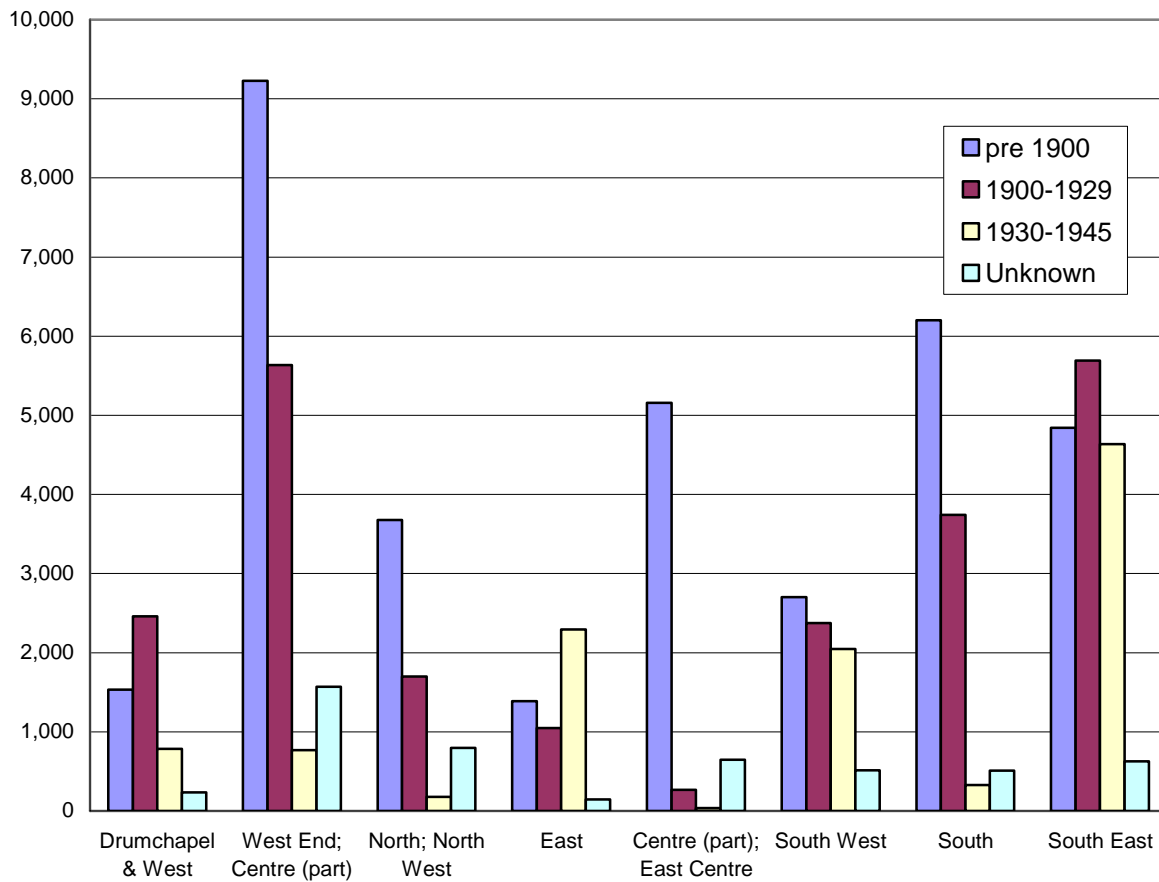
Chart 8.2 Age Bandings

8.6 The spread of age bands are shown in chart 8.2 below. Pre 1900 buildings predominate except in Drumchapel/West, East and South East.

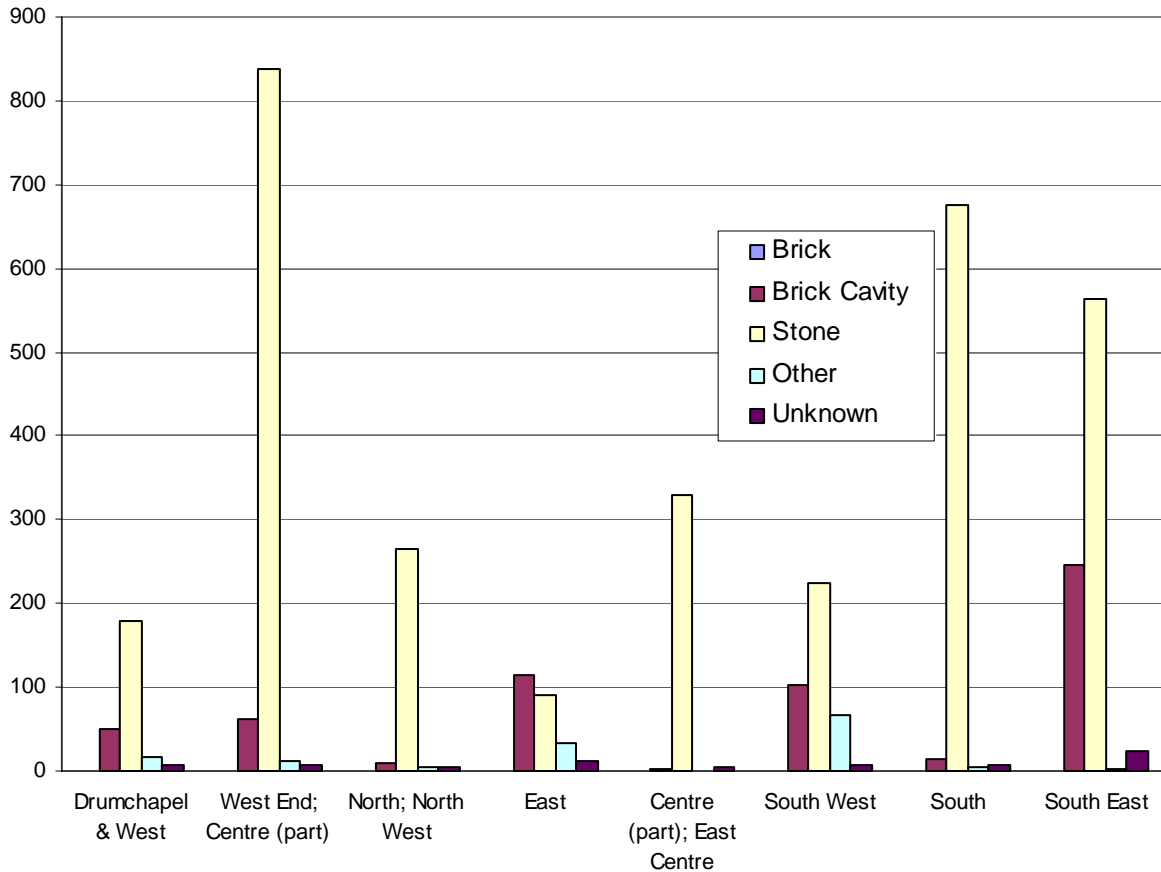
Chart 8.3 - Construction Type (ungrossed sample)

8.7 The third of the three basic attribute criteria was construction type. Given the age profile of the housing stock, the majority of dwellings built within Glasgow at that time were of solid masonry construction. There were also a number of more modern cavity built dwellings and chart 8.3 below illustrates the spread:
